**TOWN OF BROOKHAVEN
CONSCIENCE BAY AND
SETAUKET HARBOR
STORMWATER MANAGEMENT
PLAN**

Cashin Associates, P.C.

MARCH 2009

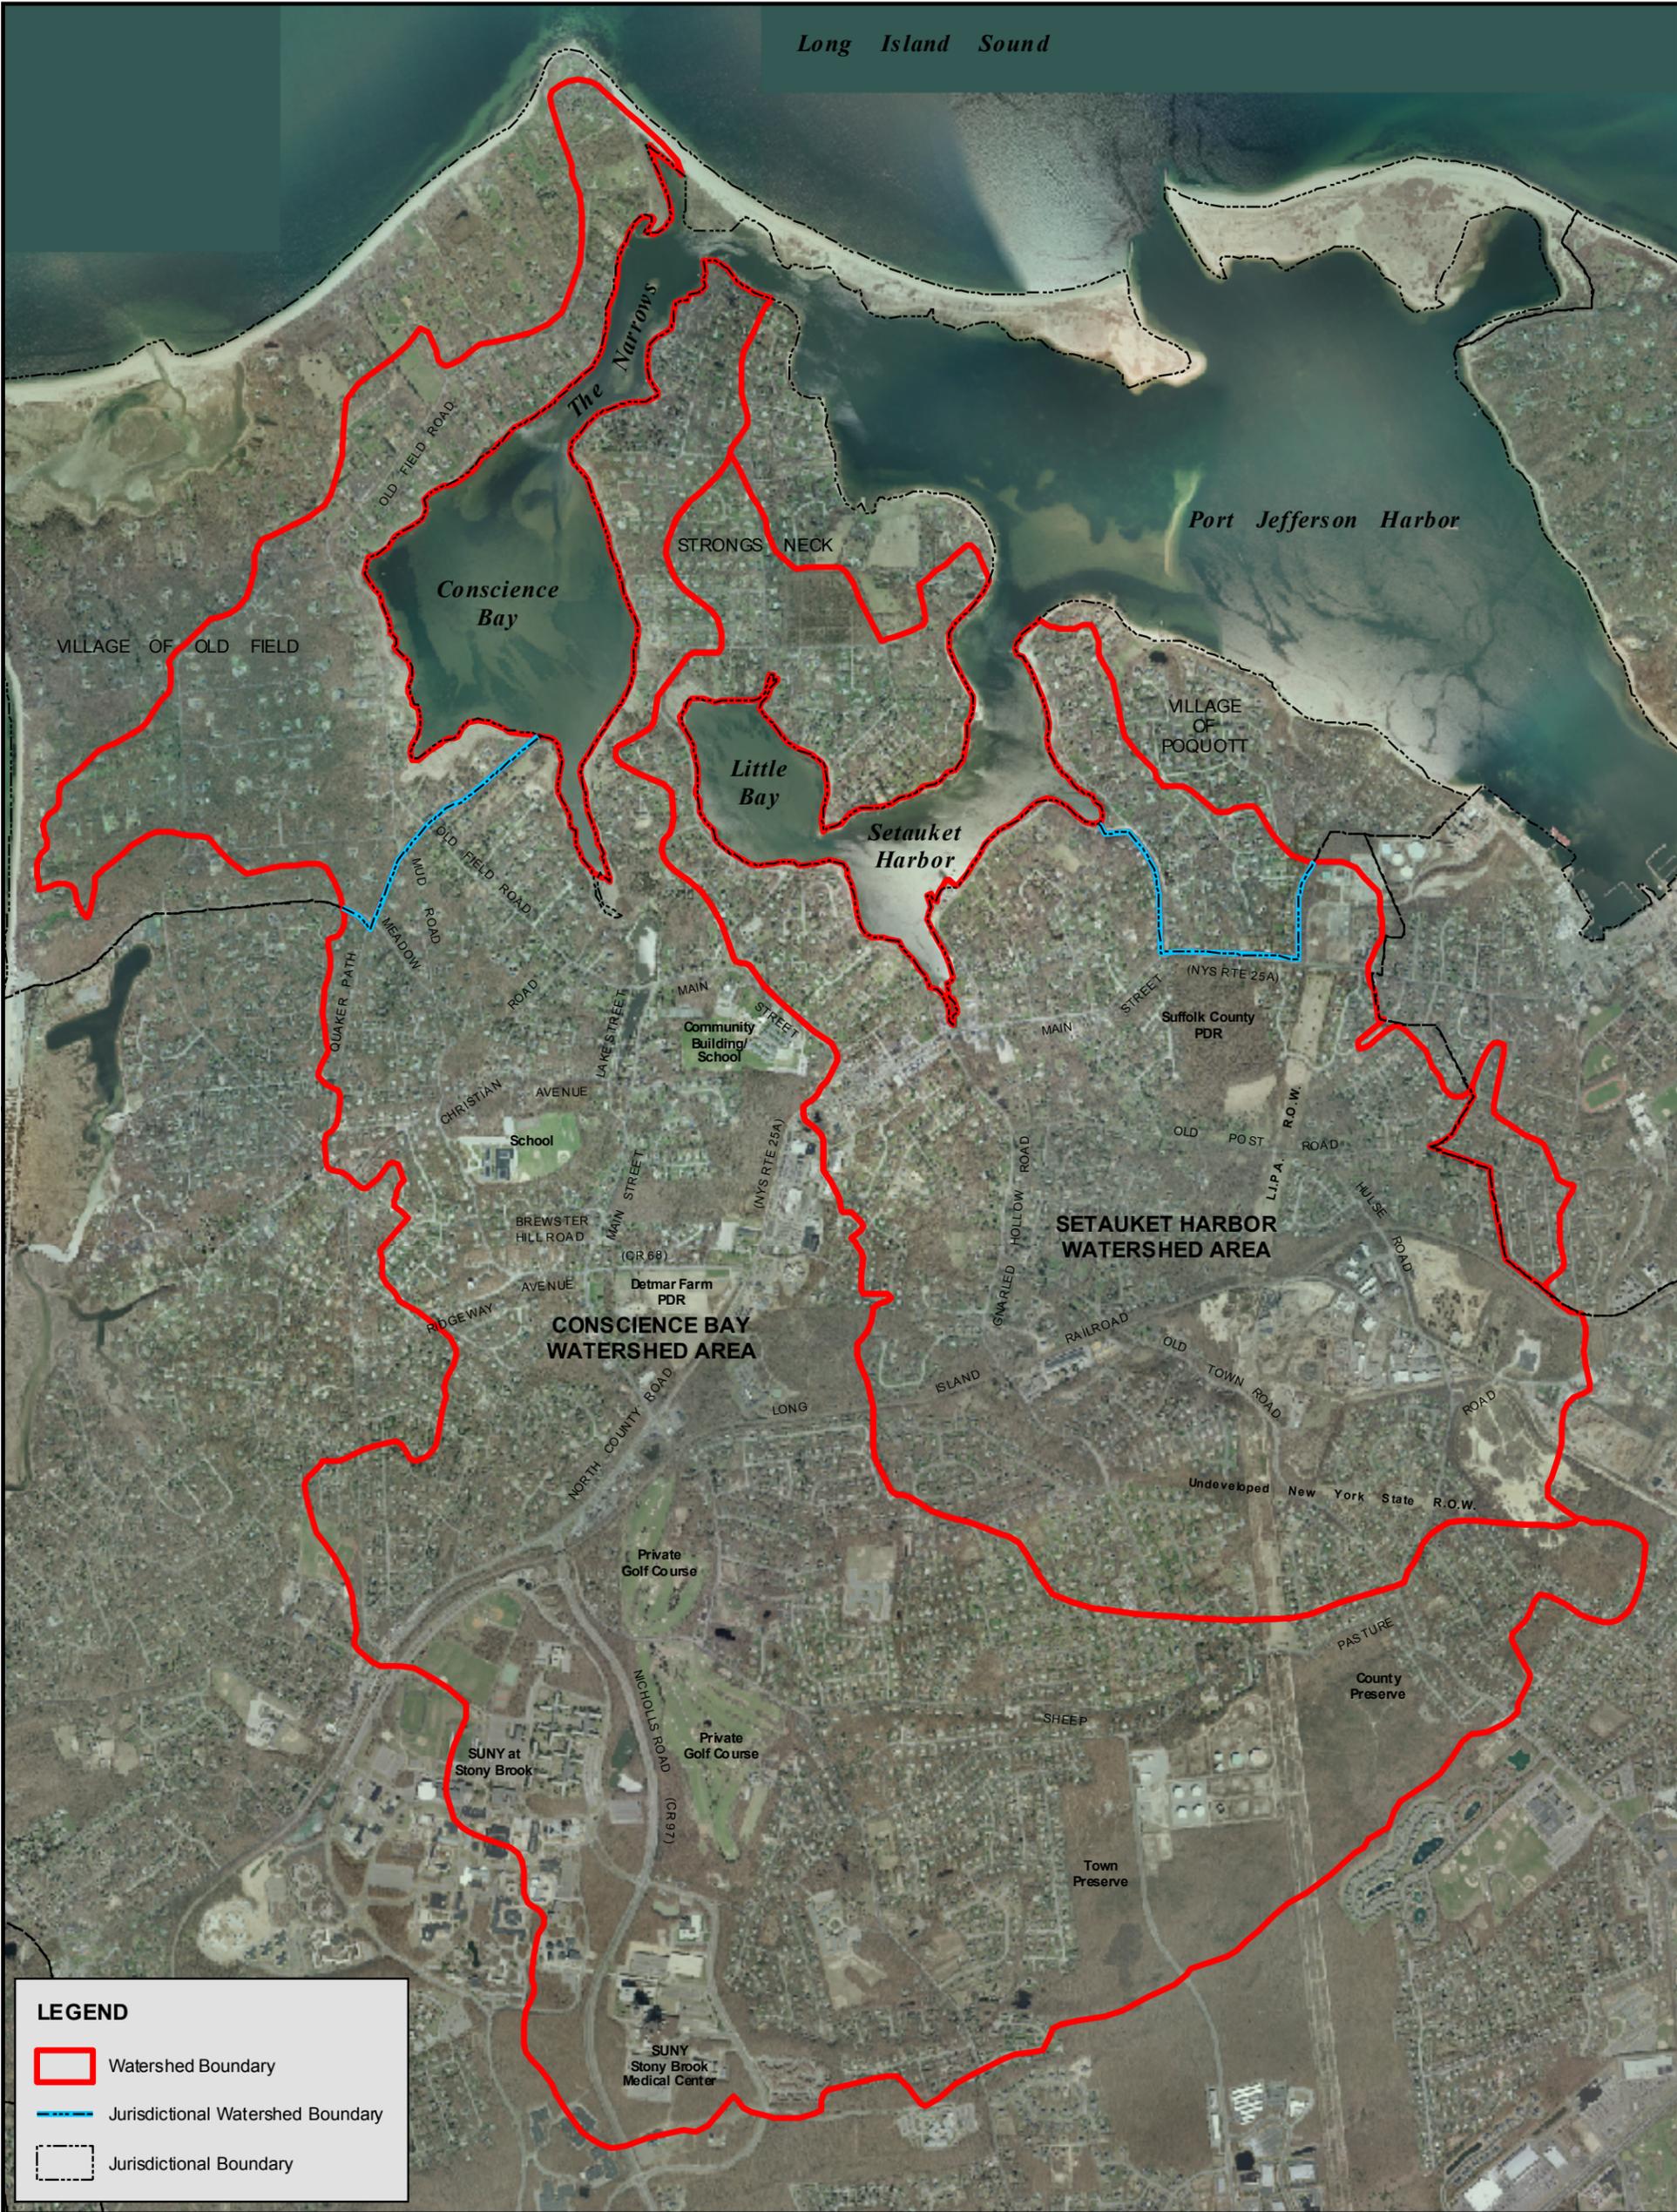
- Watershed Boundary
- Jurisdictional Watershed Boundary
- Jurisdictional Boundary

area described as self-contained is collected in drainage structures such as recharge basins or leaching pools that infiltrate to groundwater. Although groundwater has the ability to transport some pollutants to surface waters, this Plan focuses on the direct contribution from surface outfalls. The watershed boundary and the surface drainage boundary are shown on Map 1.

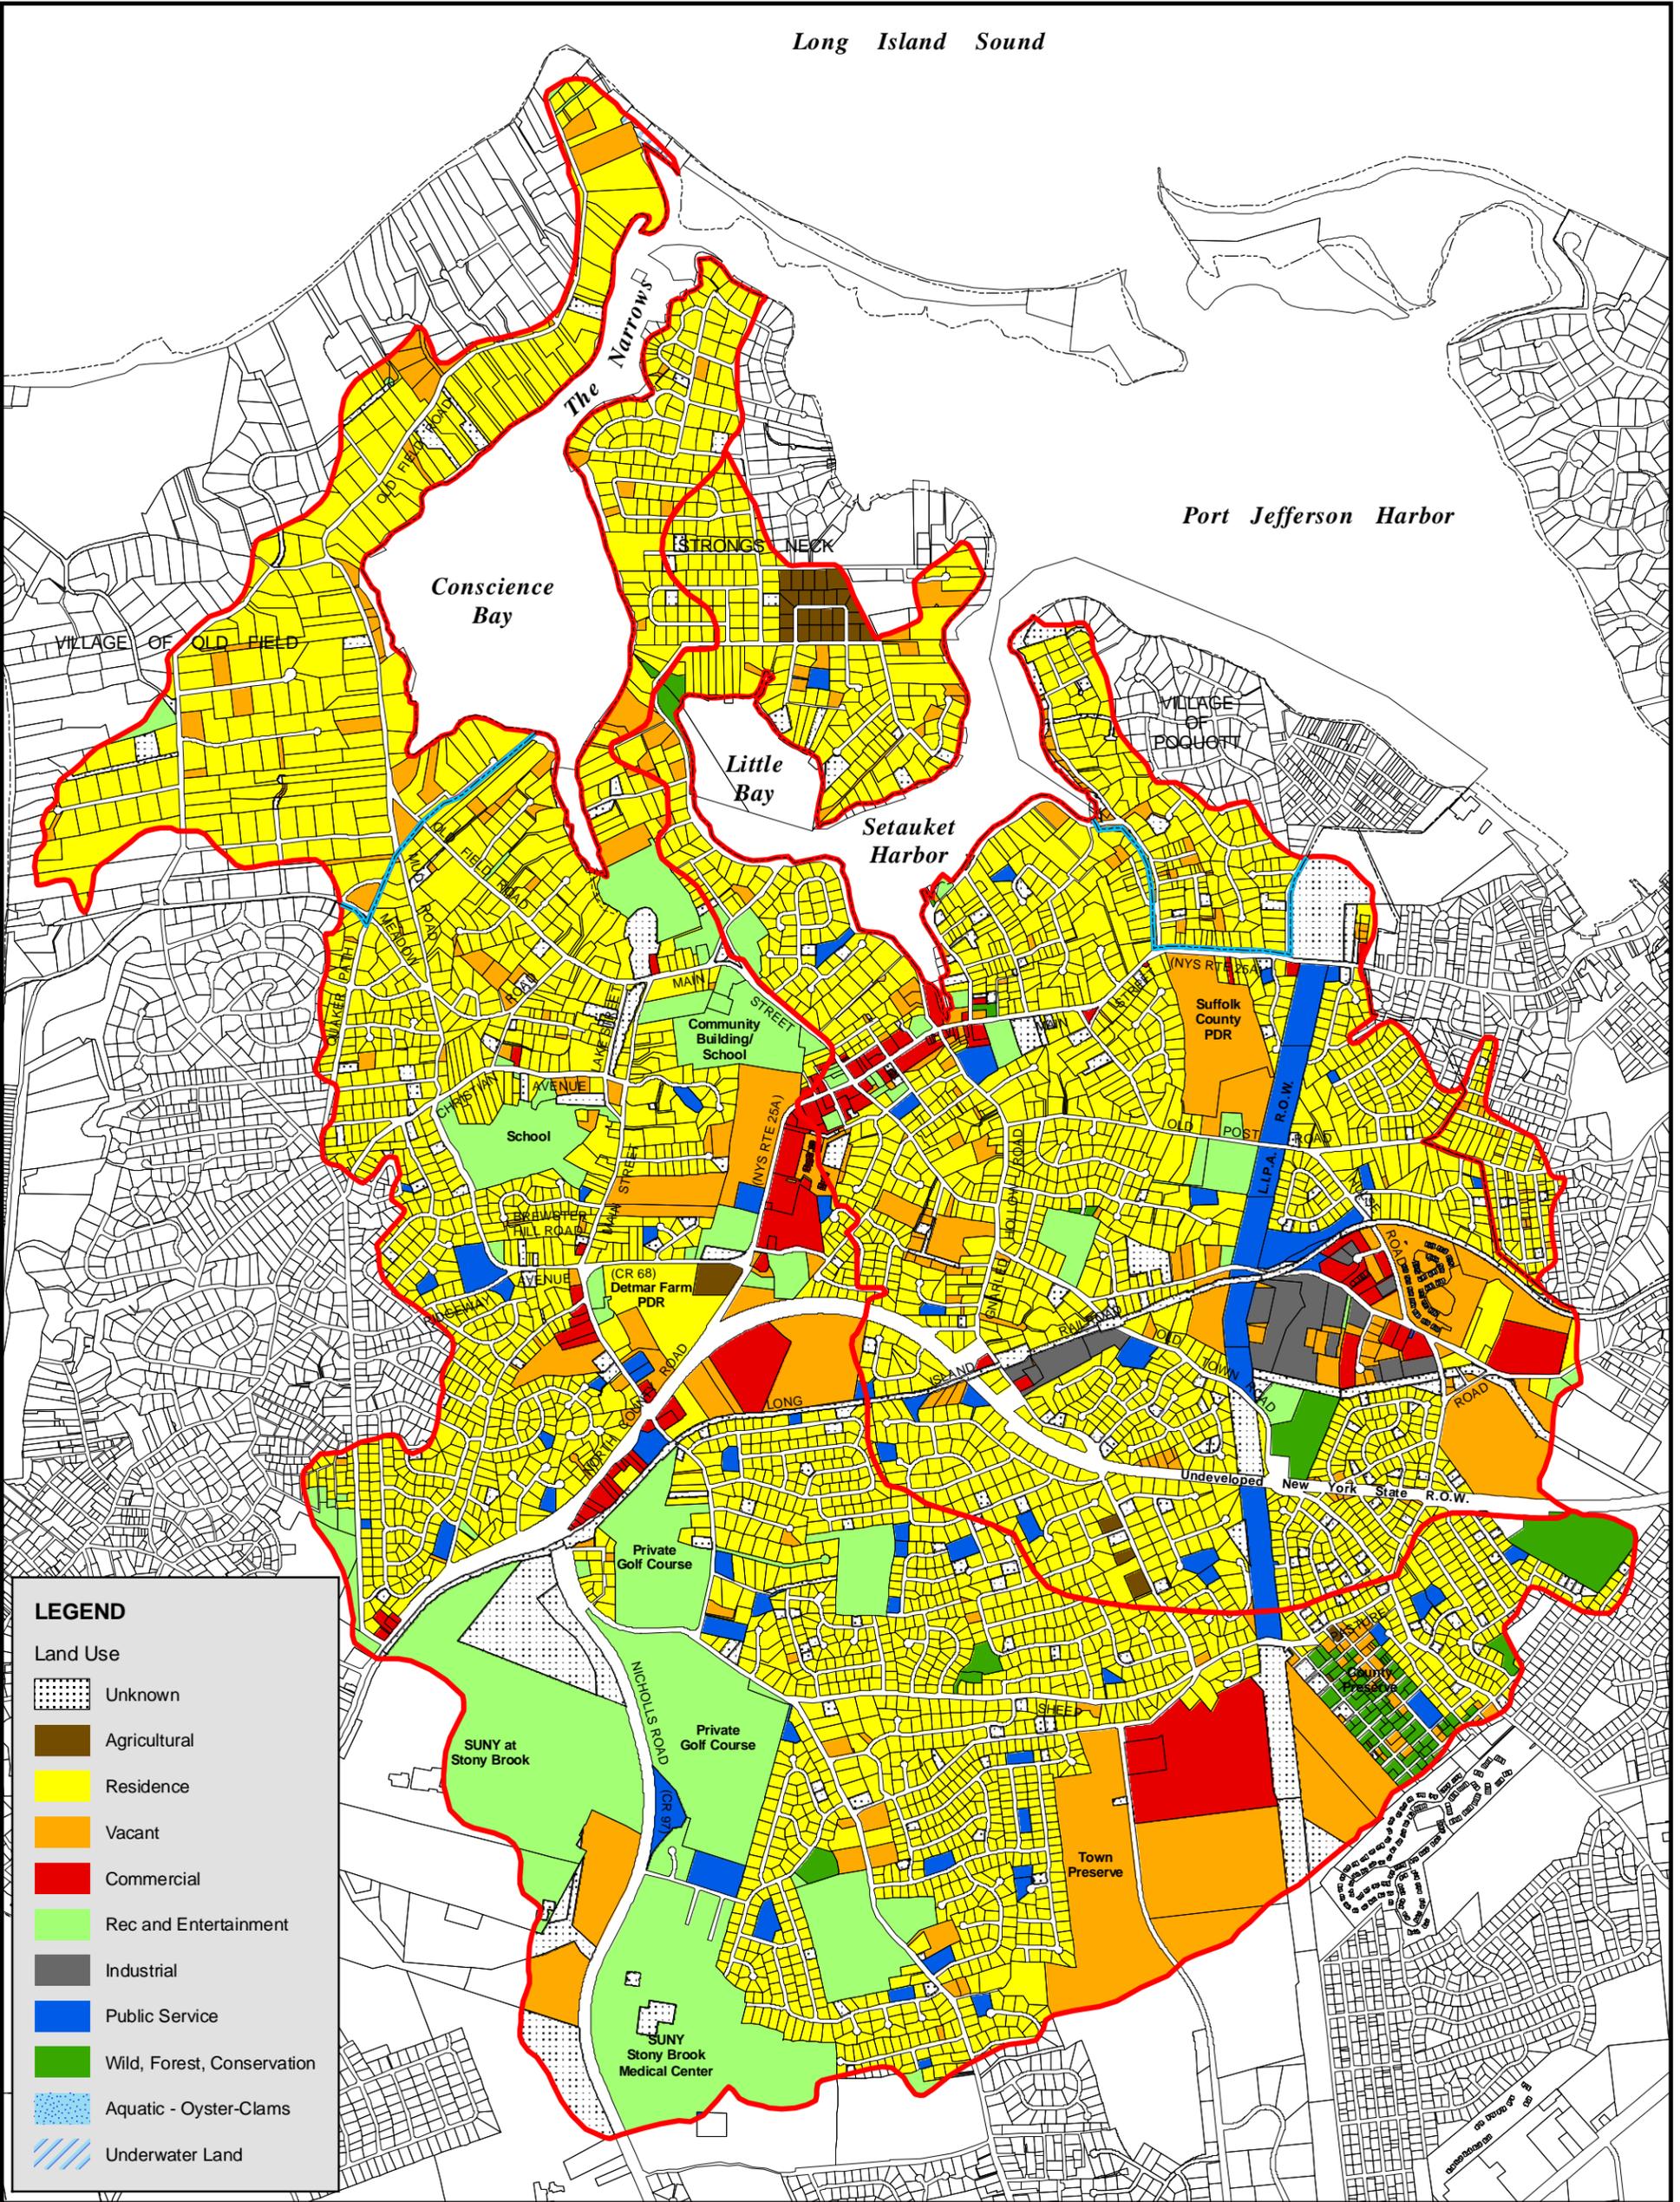
Land Use

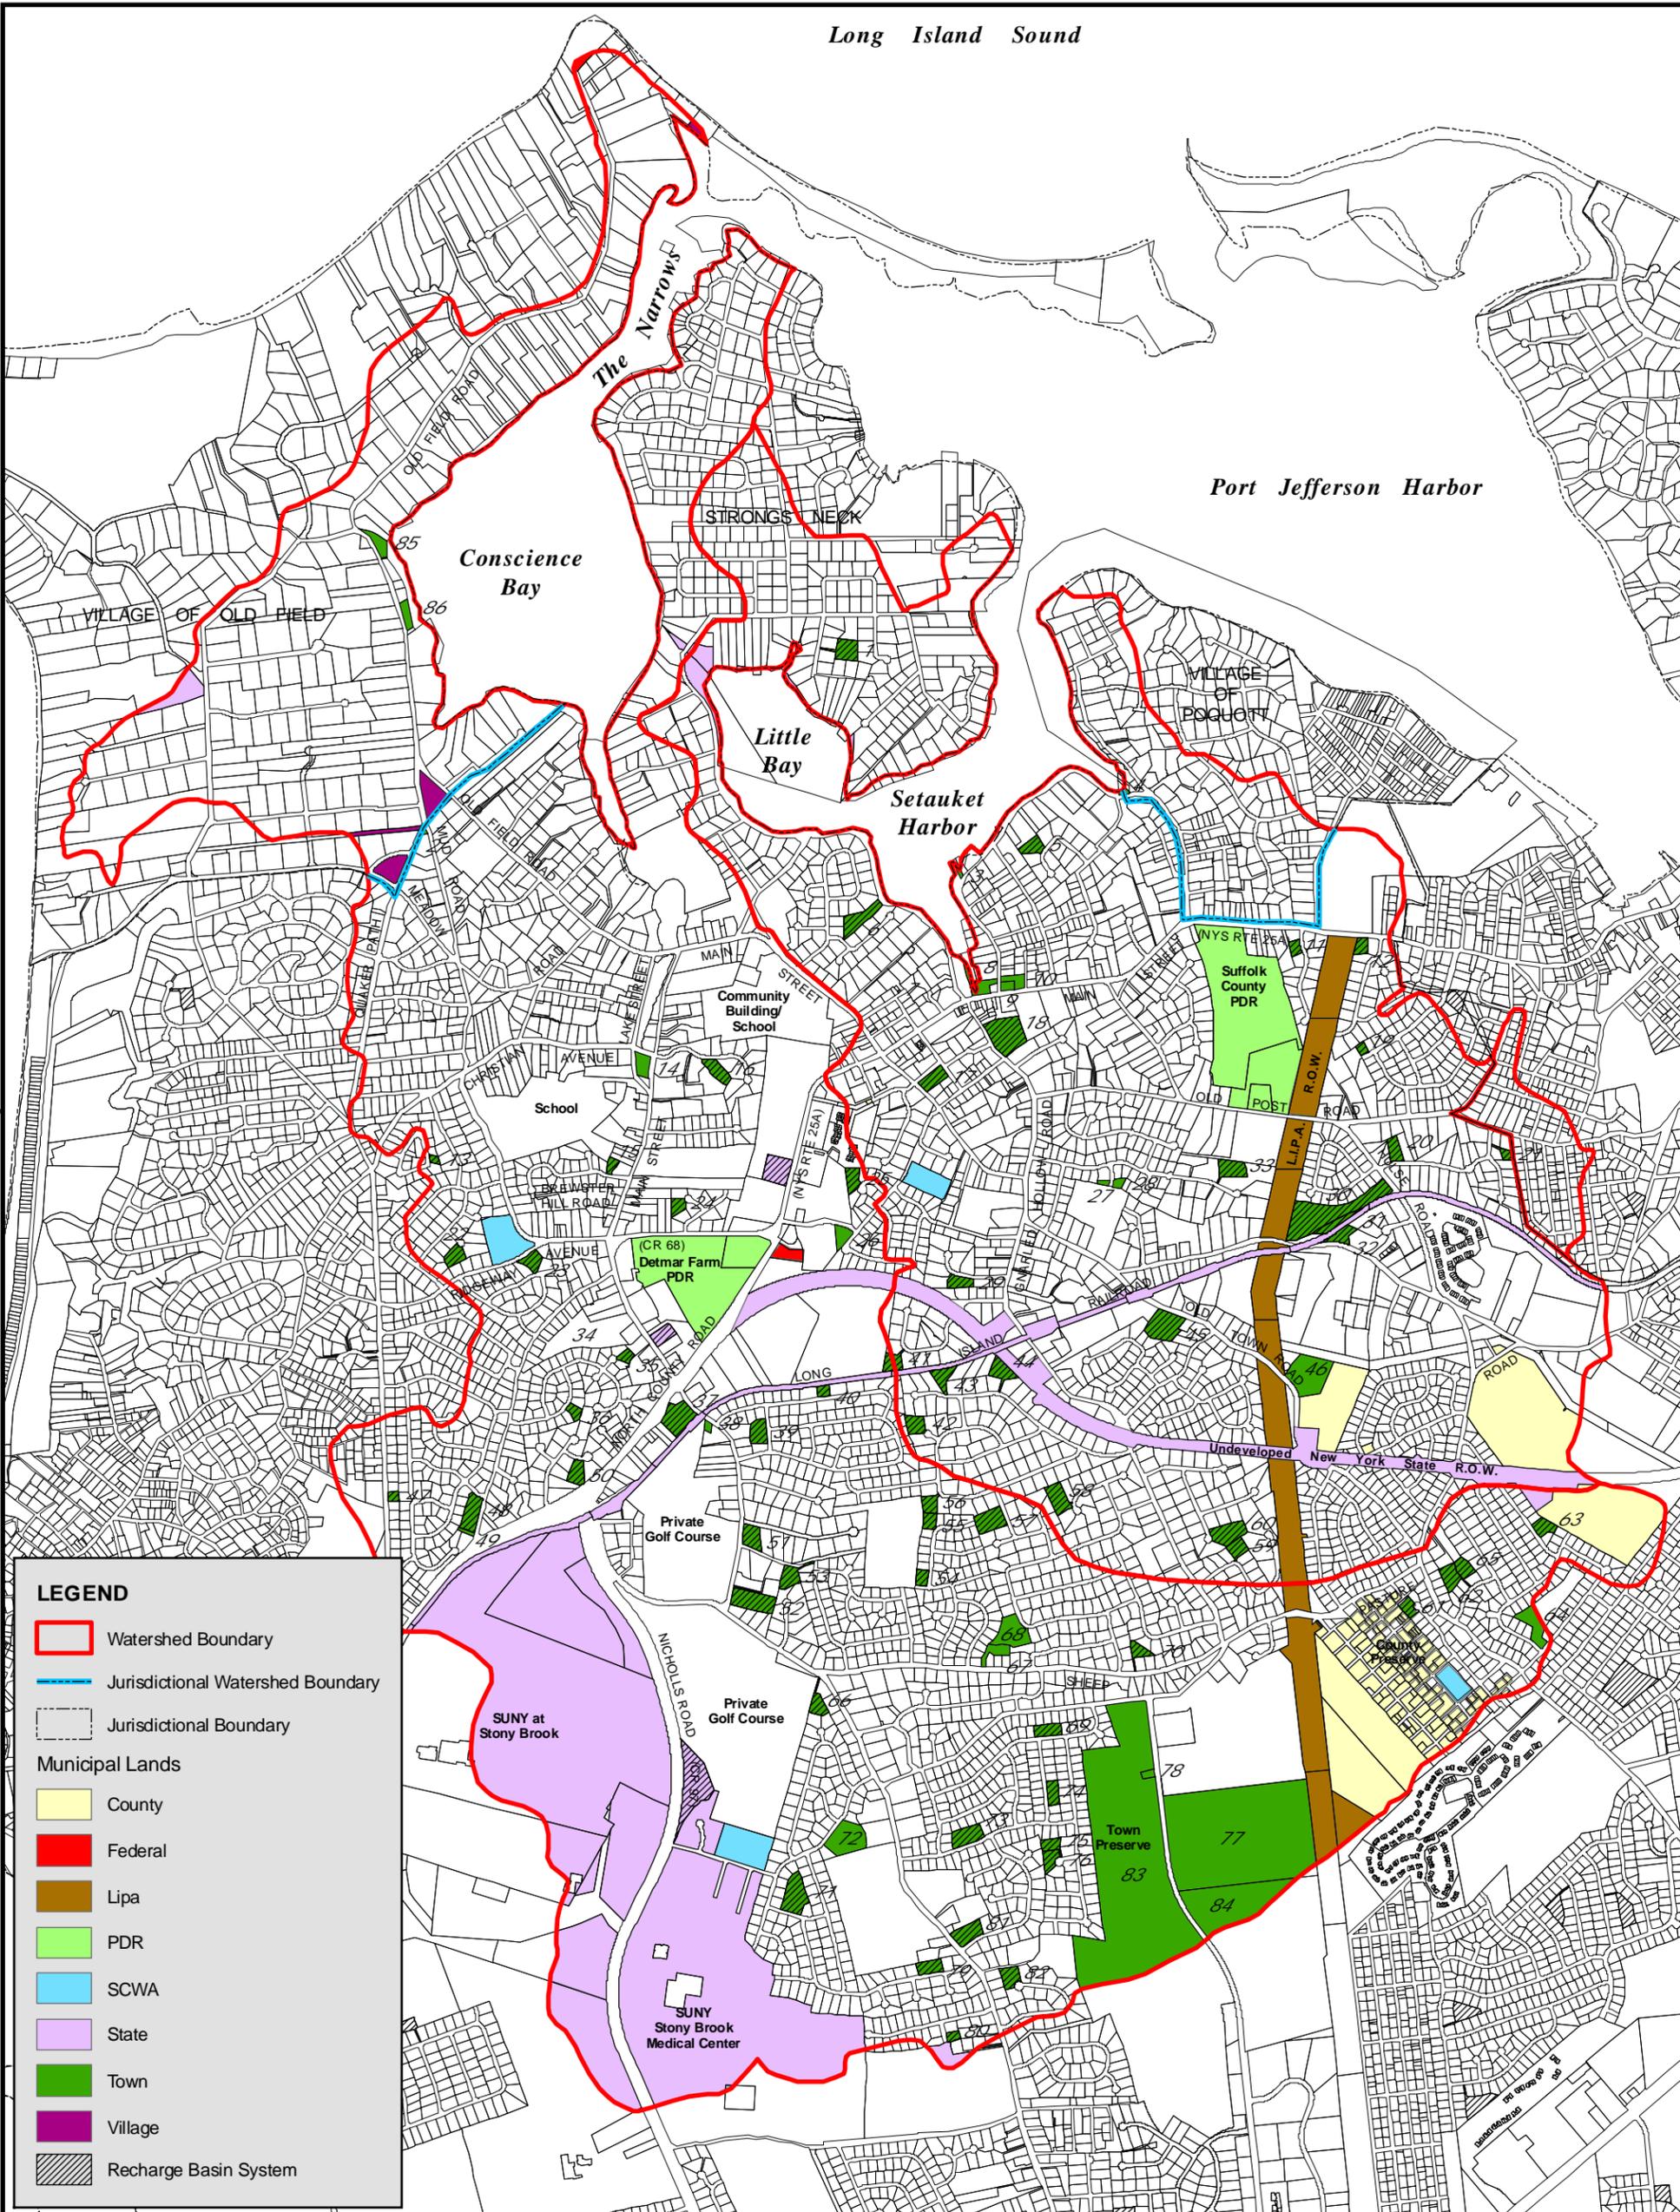
Conscience Bay and Setauket Harbor
 Watershed Plan
 Municipal Lands and Recharge Basins
 Map 3

Land Ownership/Recharge Basins Source: Town of Brookhaven GIS

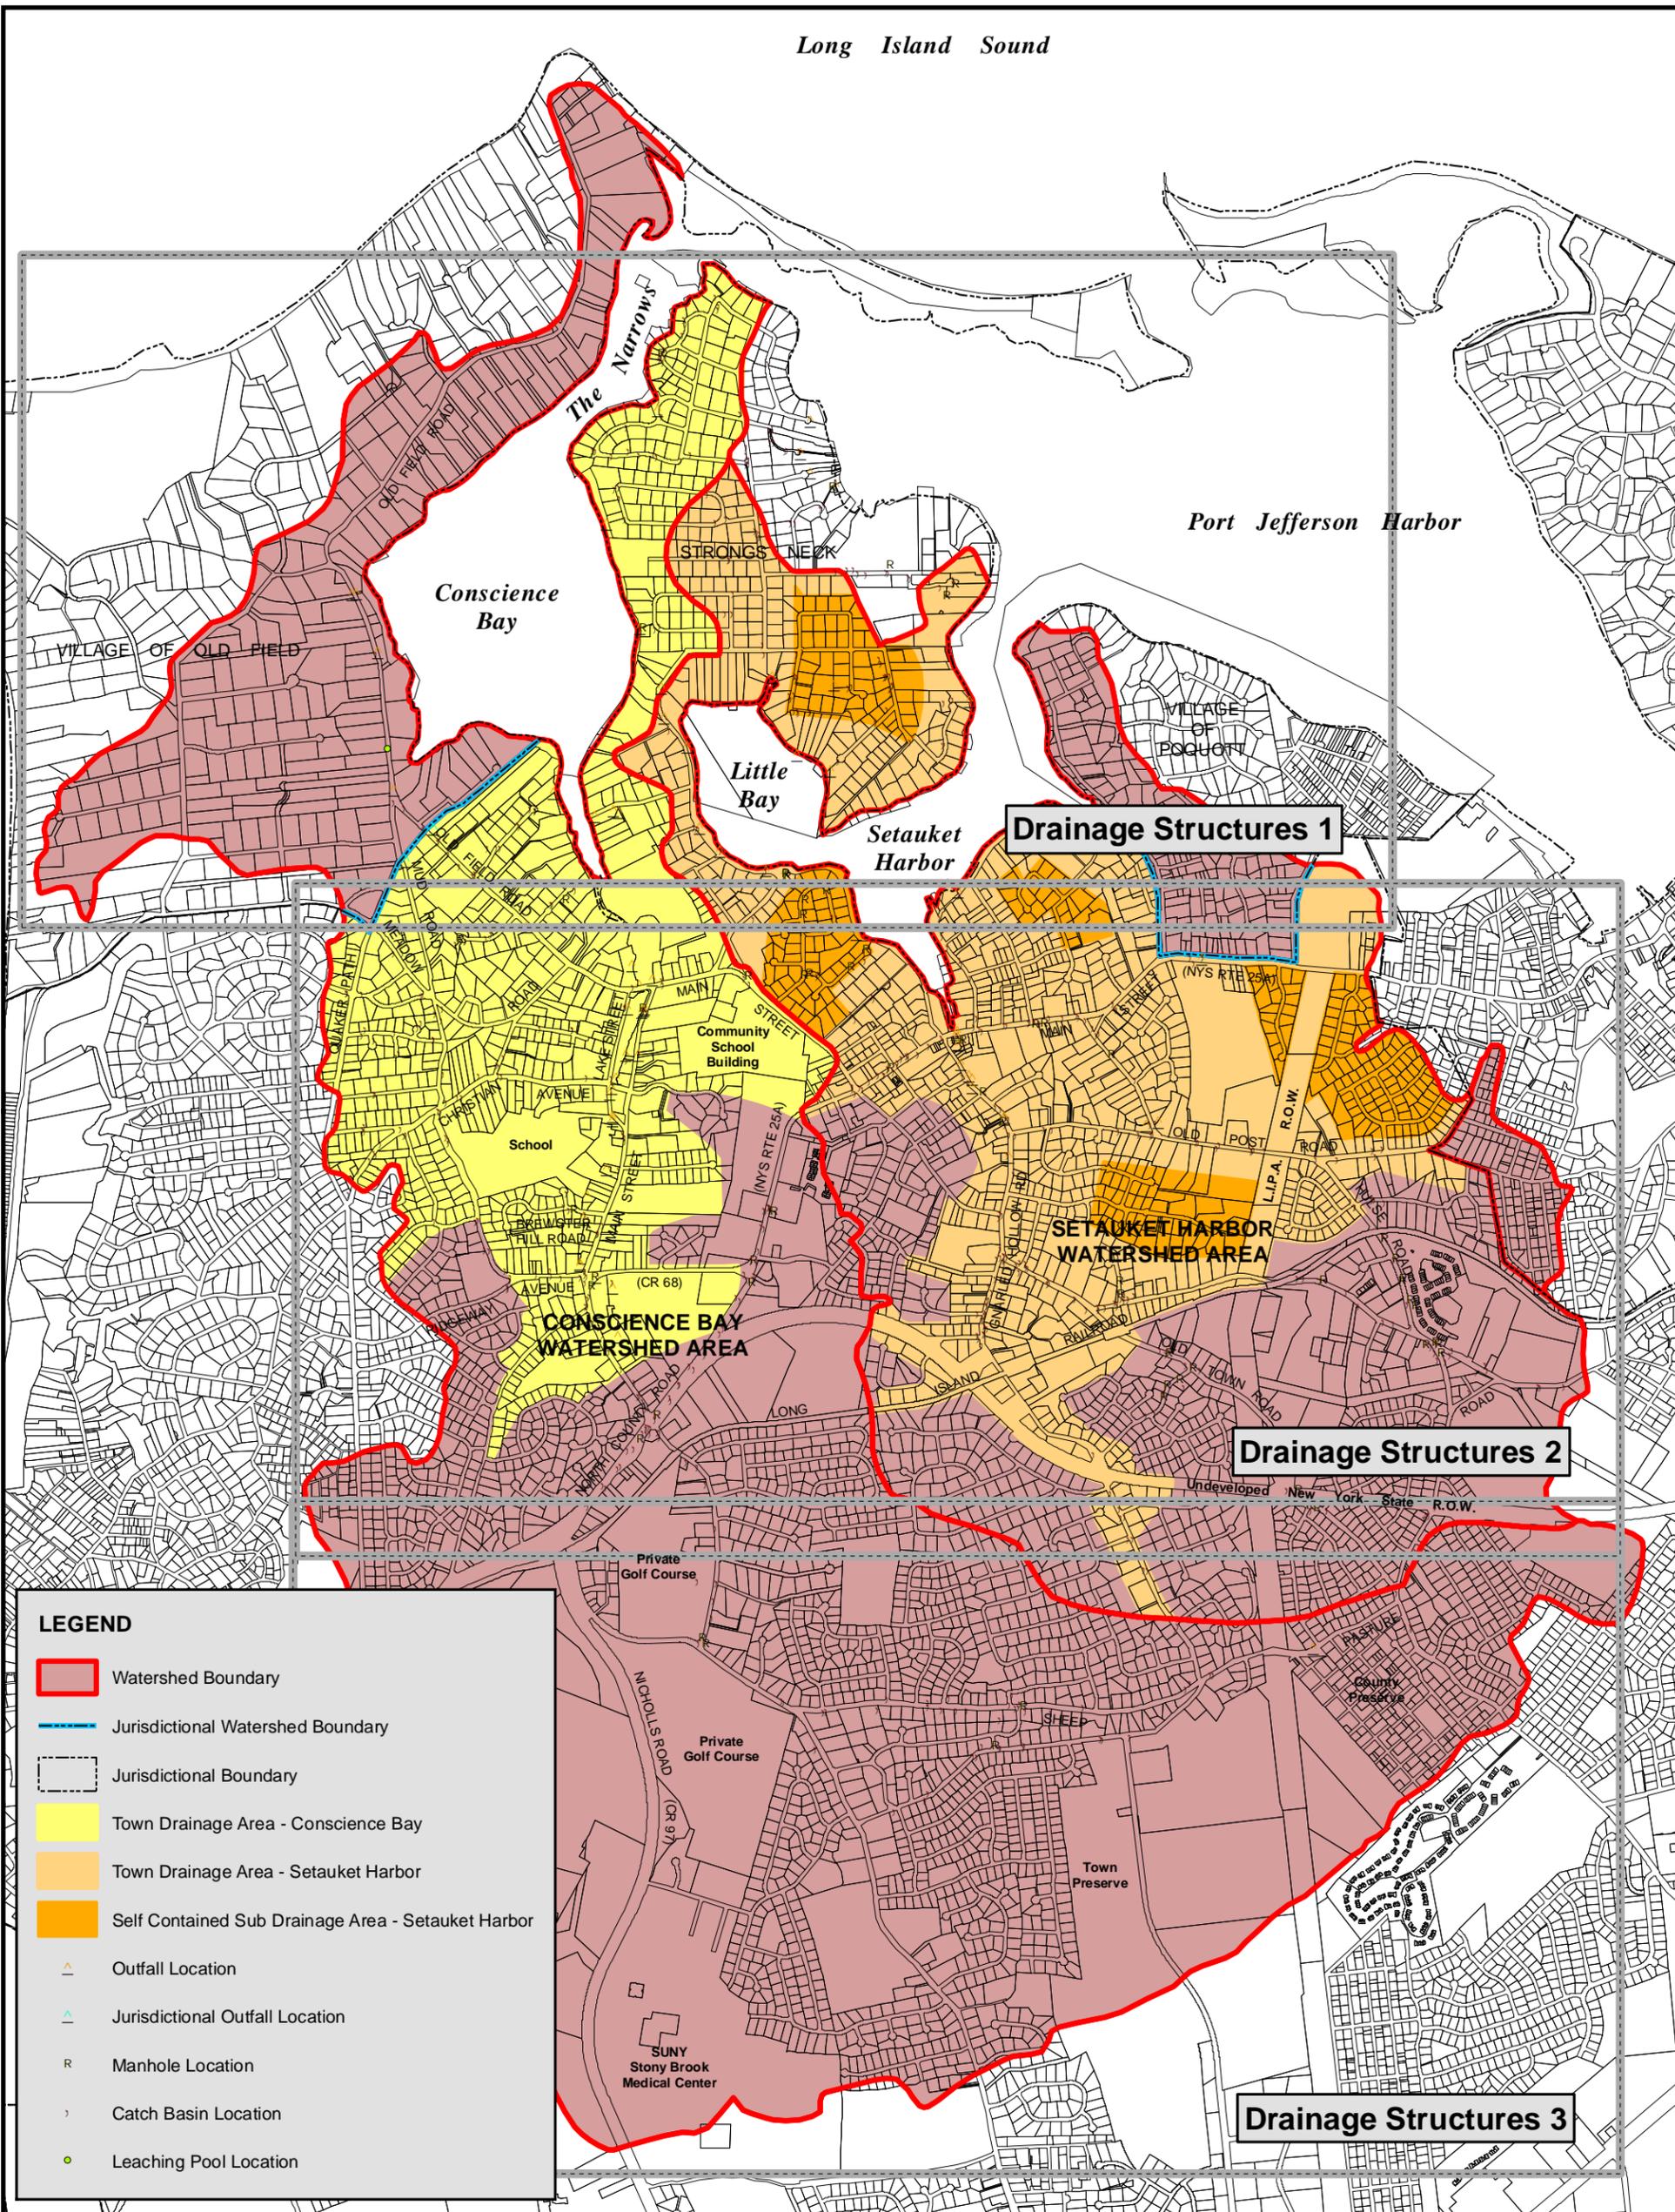
Map 5

- Watershed Boundary
- Jurisdictional Watershed Boundary
- Jurisdictional Boundary
- Town Drainage Area - Conscience Bay
- Town Drainage Area - Setauket Harbor
- Self Contained Sub Drainage Area - Setauket Harbor
- ▲ Outfall Location
- ▲ Jurisdictional Outfall Location
- R Manhole Location
- ⌋ Catch Basin Location
- Leaching Pool Location

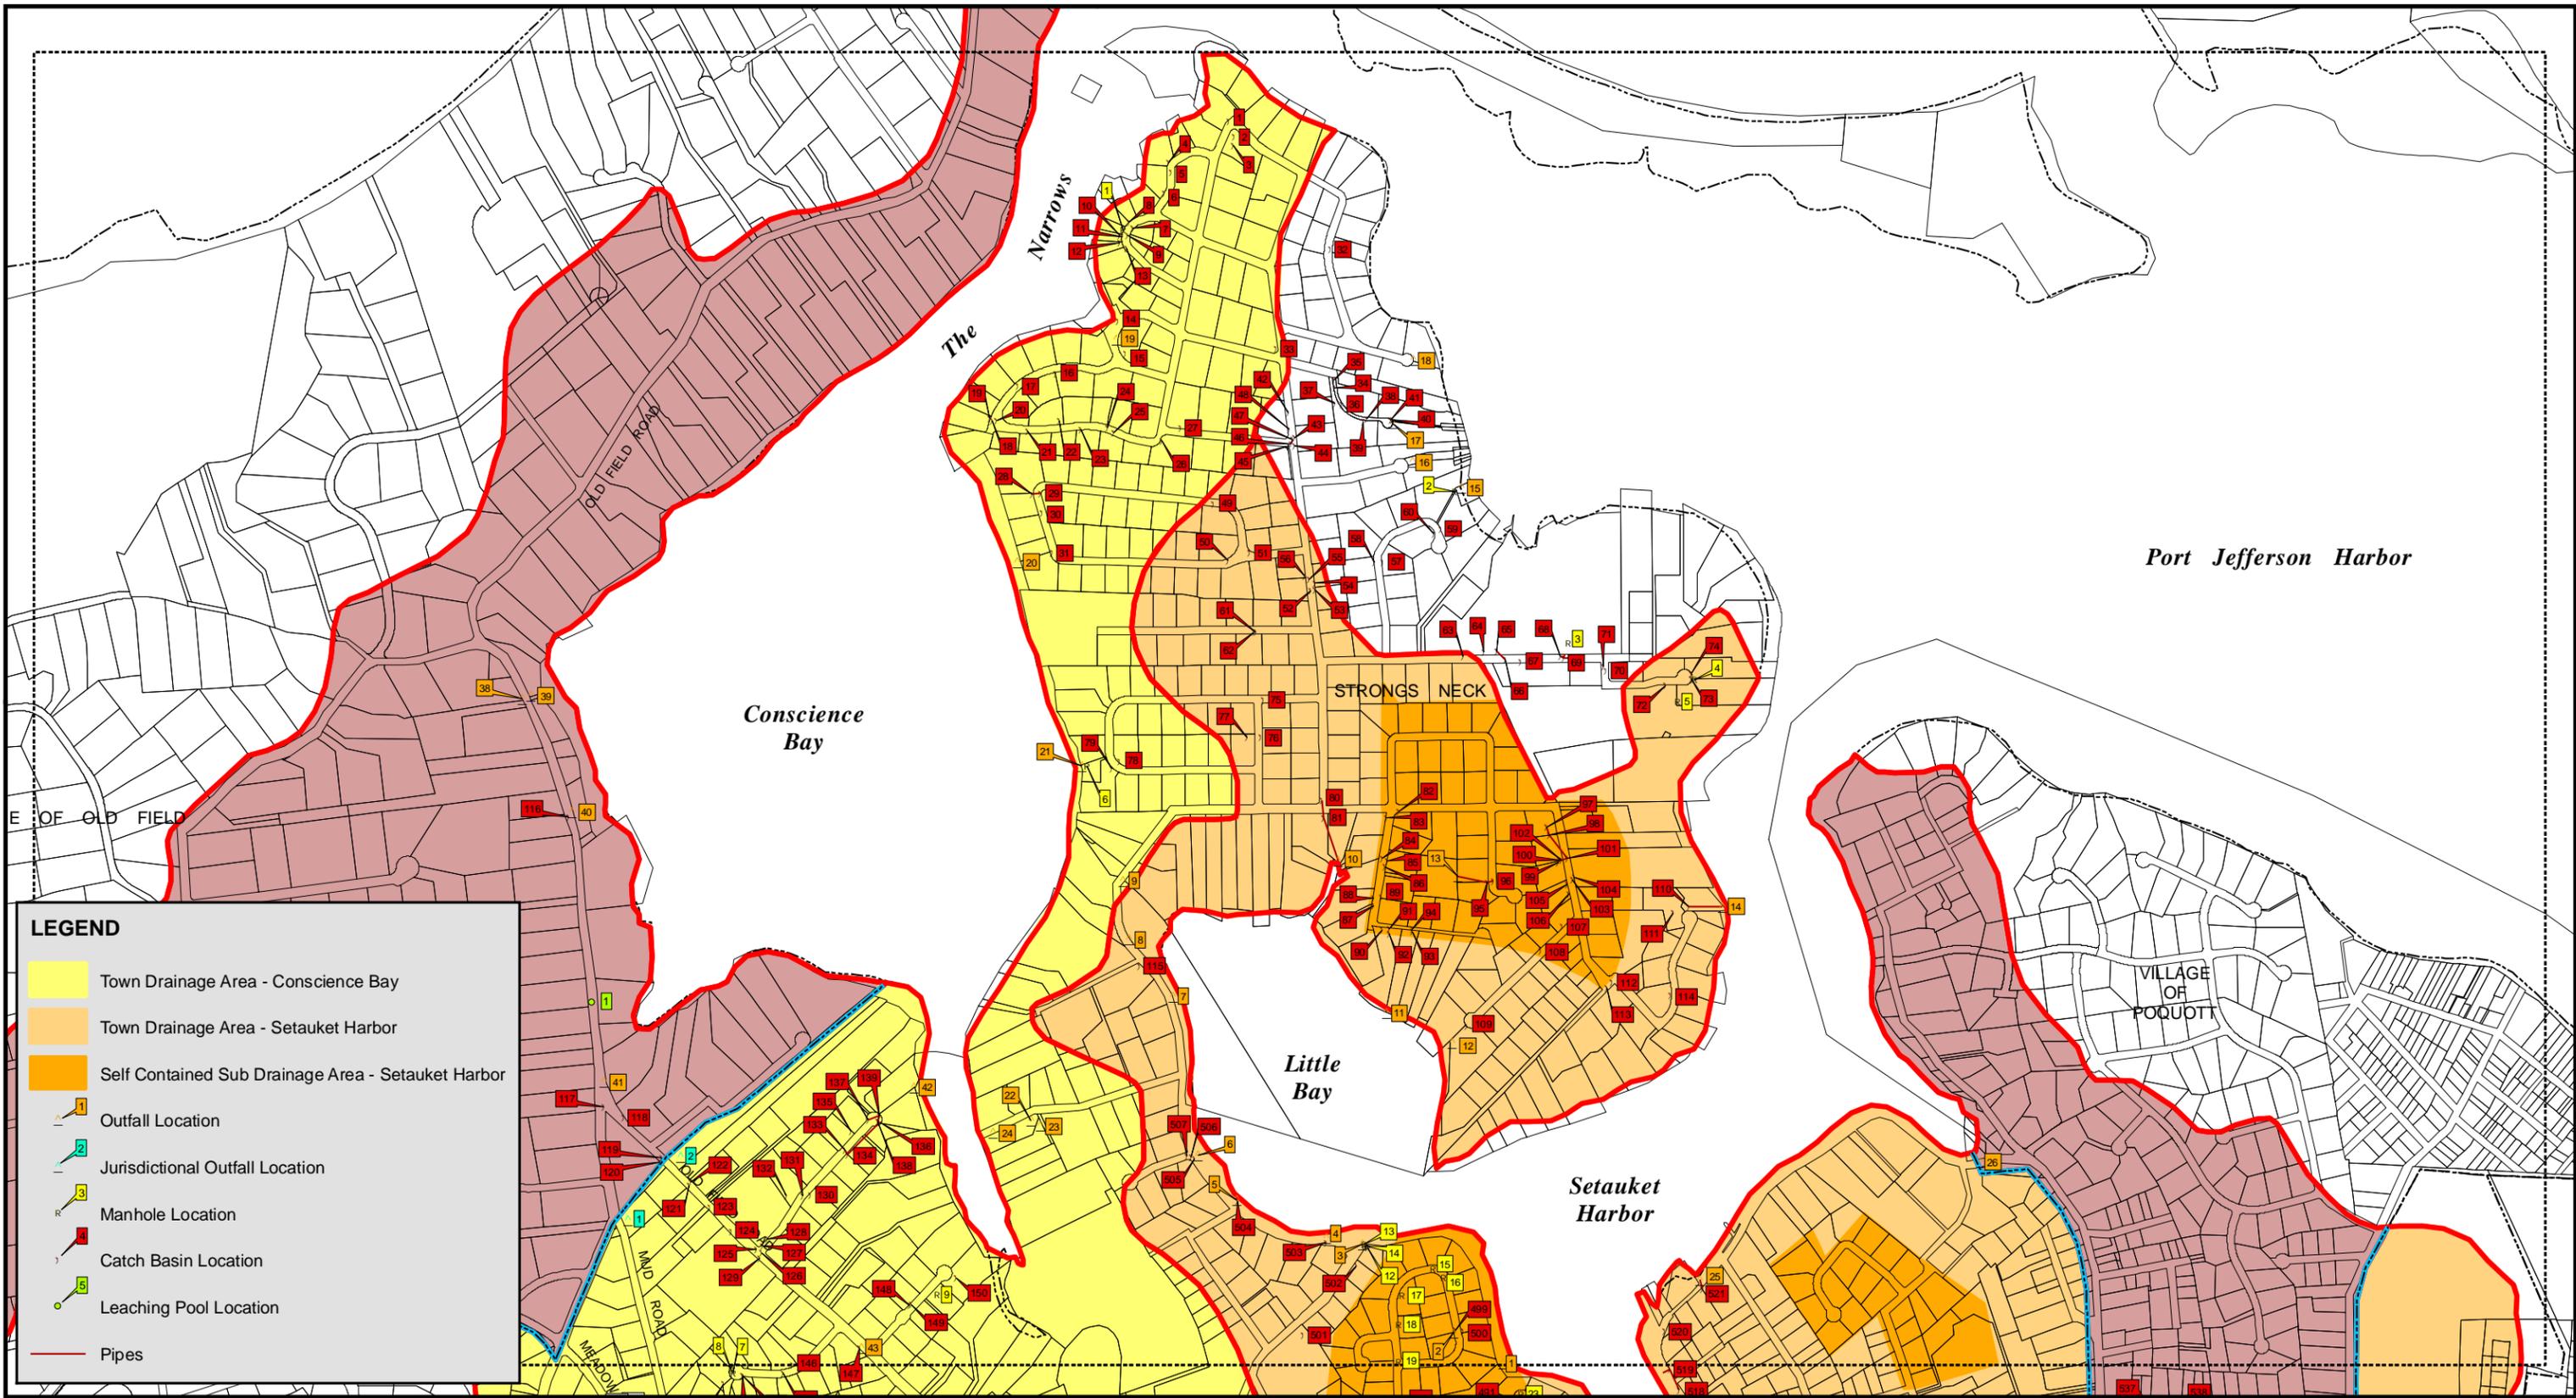
Conscience Bay and Setauket Harbor
 Watershed Plan
 Drainage Structures 1
 Map 5-1

- Town Drainage Area - Conscience Bay
- Town Drainage Area - Setauket Harbor
- Self Contained Sub Drainage Area - Setauket Harbor
- 1 Outfall Location
- 2 Jurisdictional Outfall Location
- 3 Manhole Location
- 4 Catch Basin Location
- 5 Leaching Pool Location
- Pipes

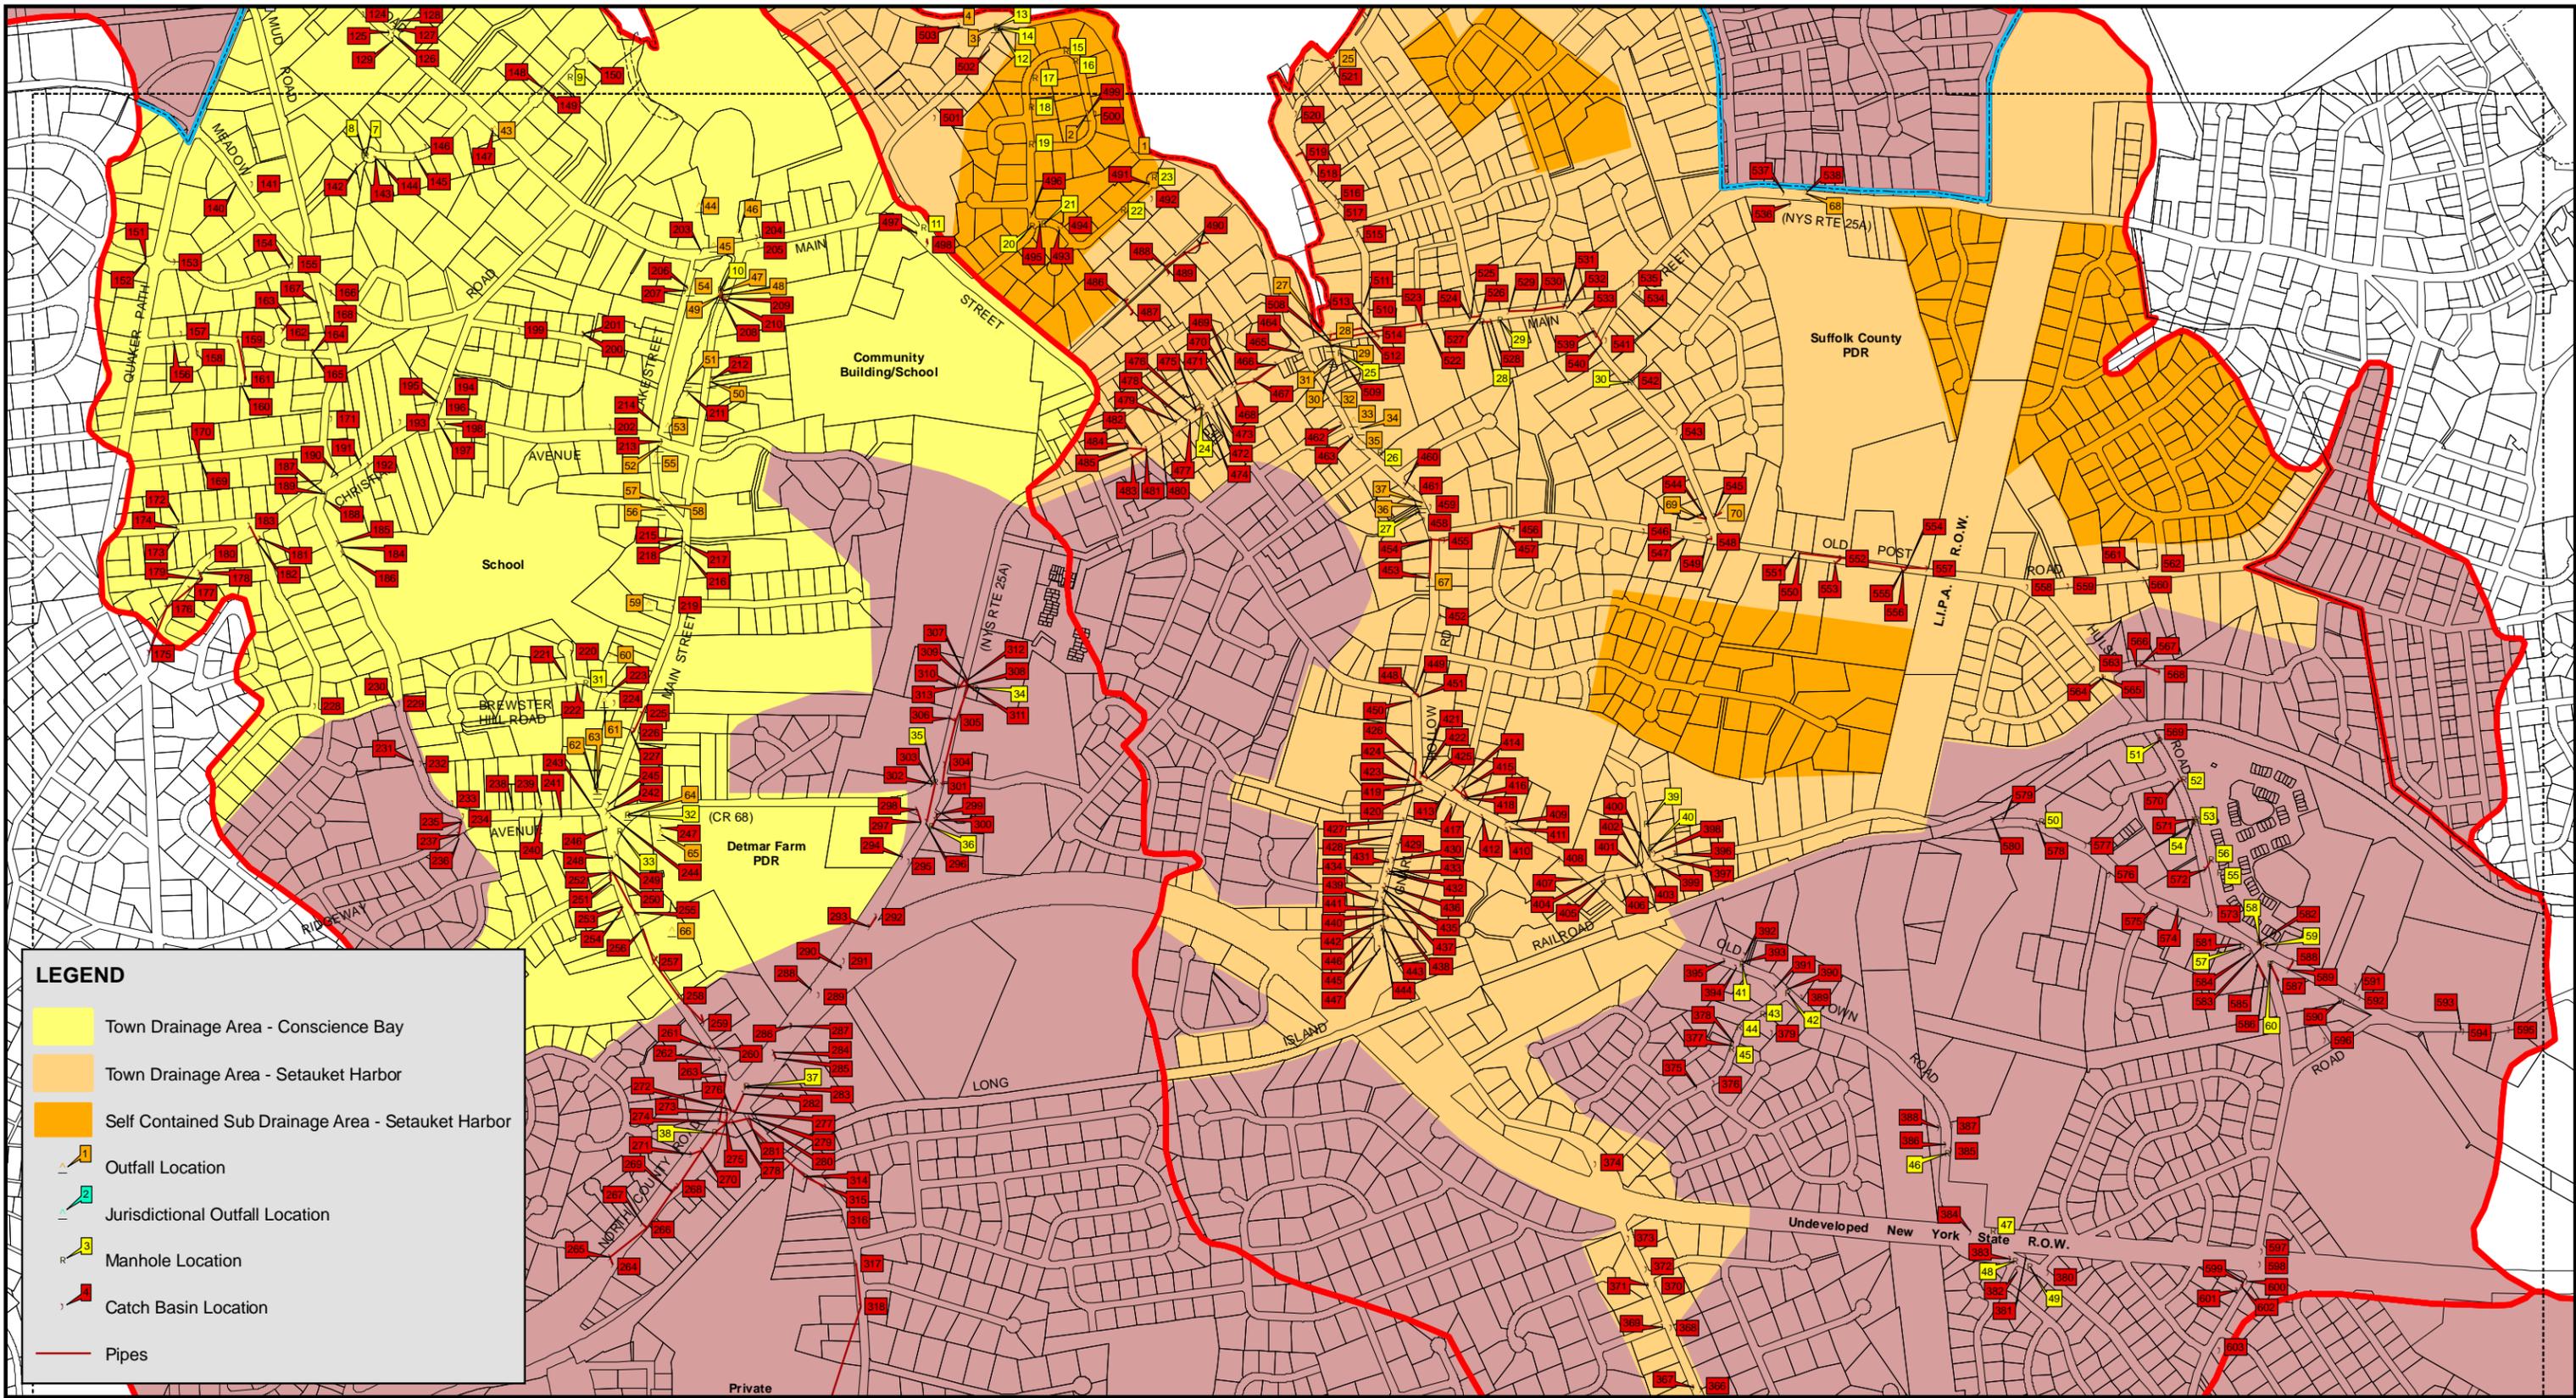
Conscience Bay and Setauket Harbor
Watershed Plan
Drainage Structures 2
Map 5-2

- Town Drainage Area - Conscience Bay
- Town Drainage Area - Setauket Harbor
- Self Contained Sub Drainage Area - Setauket Harbor
- 1 Outfall Location
- 2 Jurisdictional Outfall Location
- 3 Manhole Location
- 4 Catch Basin Location
- Pipes
