**TOWN OF BROOKHAVEN
CONSCIENCE BAY AND
SETAUKET HARBOR
STORMWATER MANAGEMENT
PLAN**

Cashin Associates, P.C.

MARCH 2009

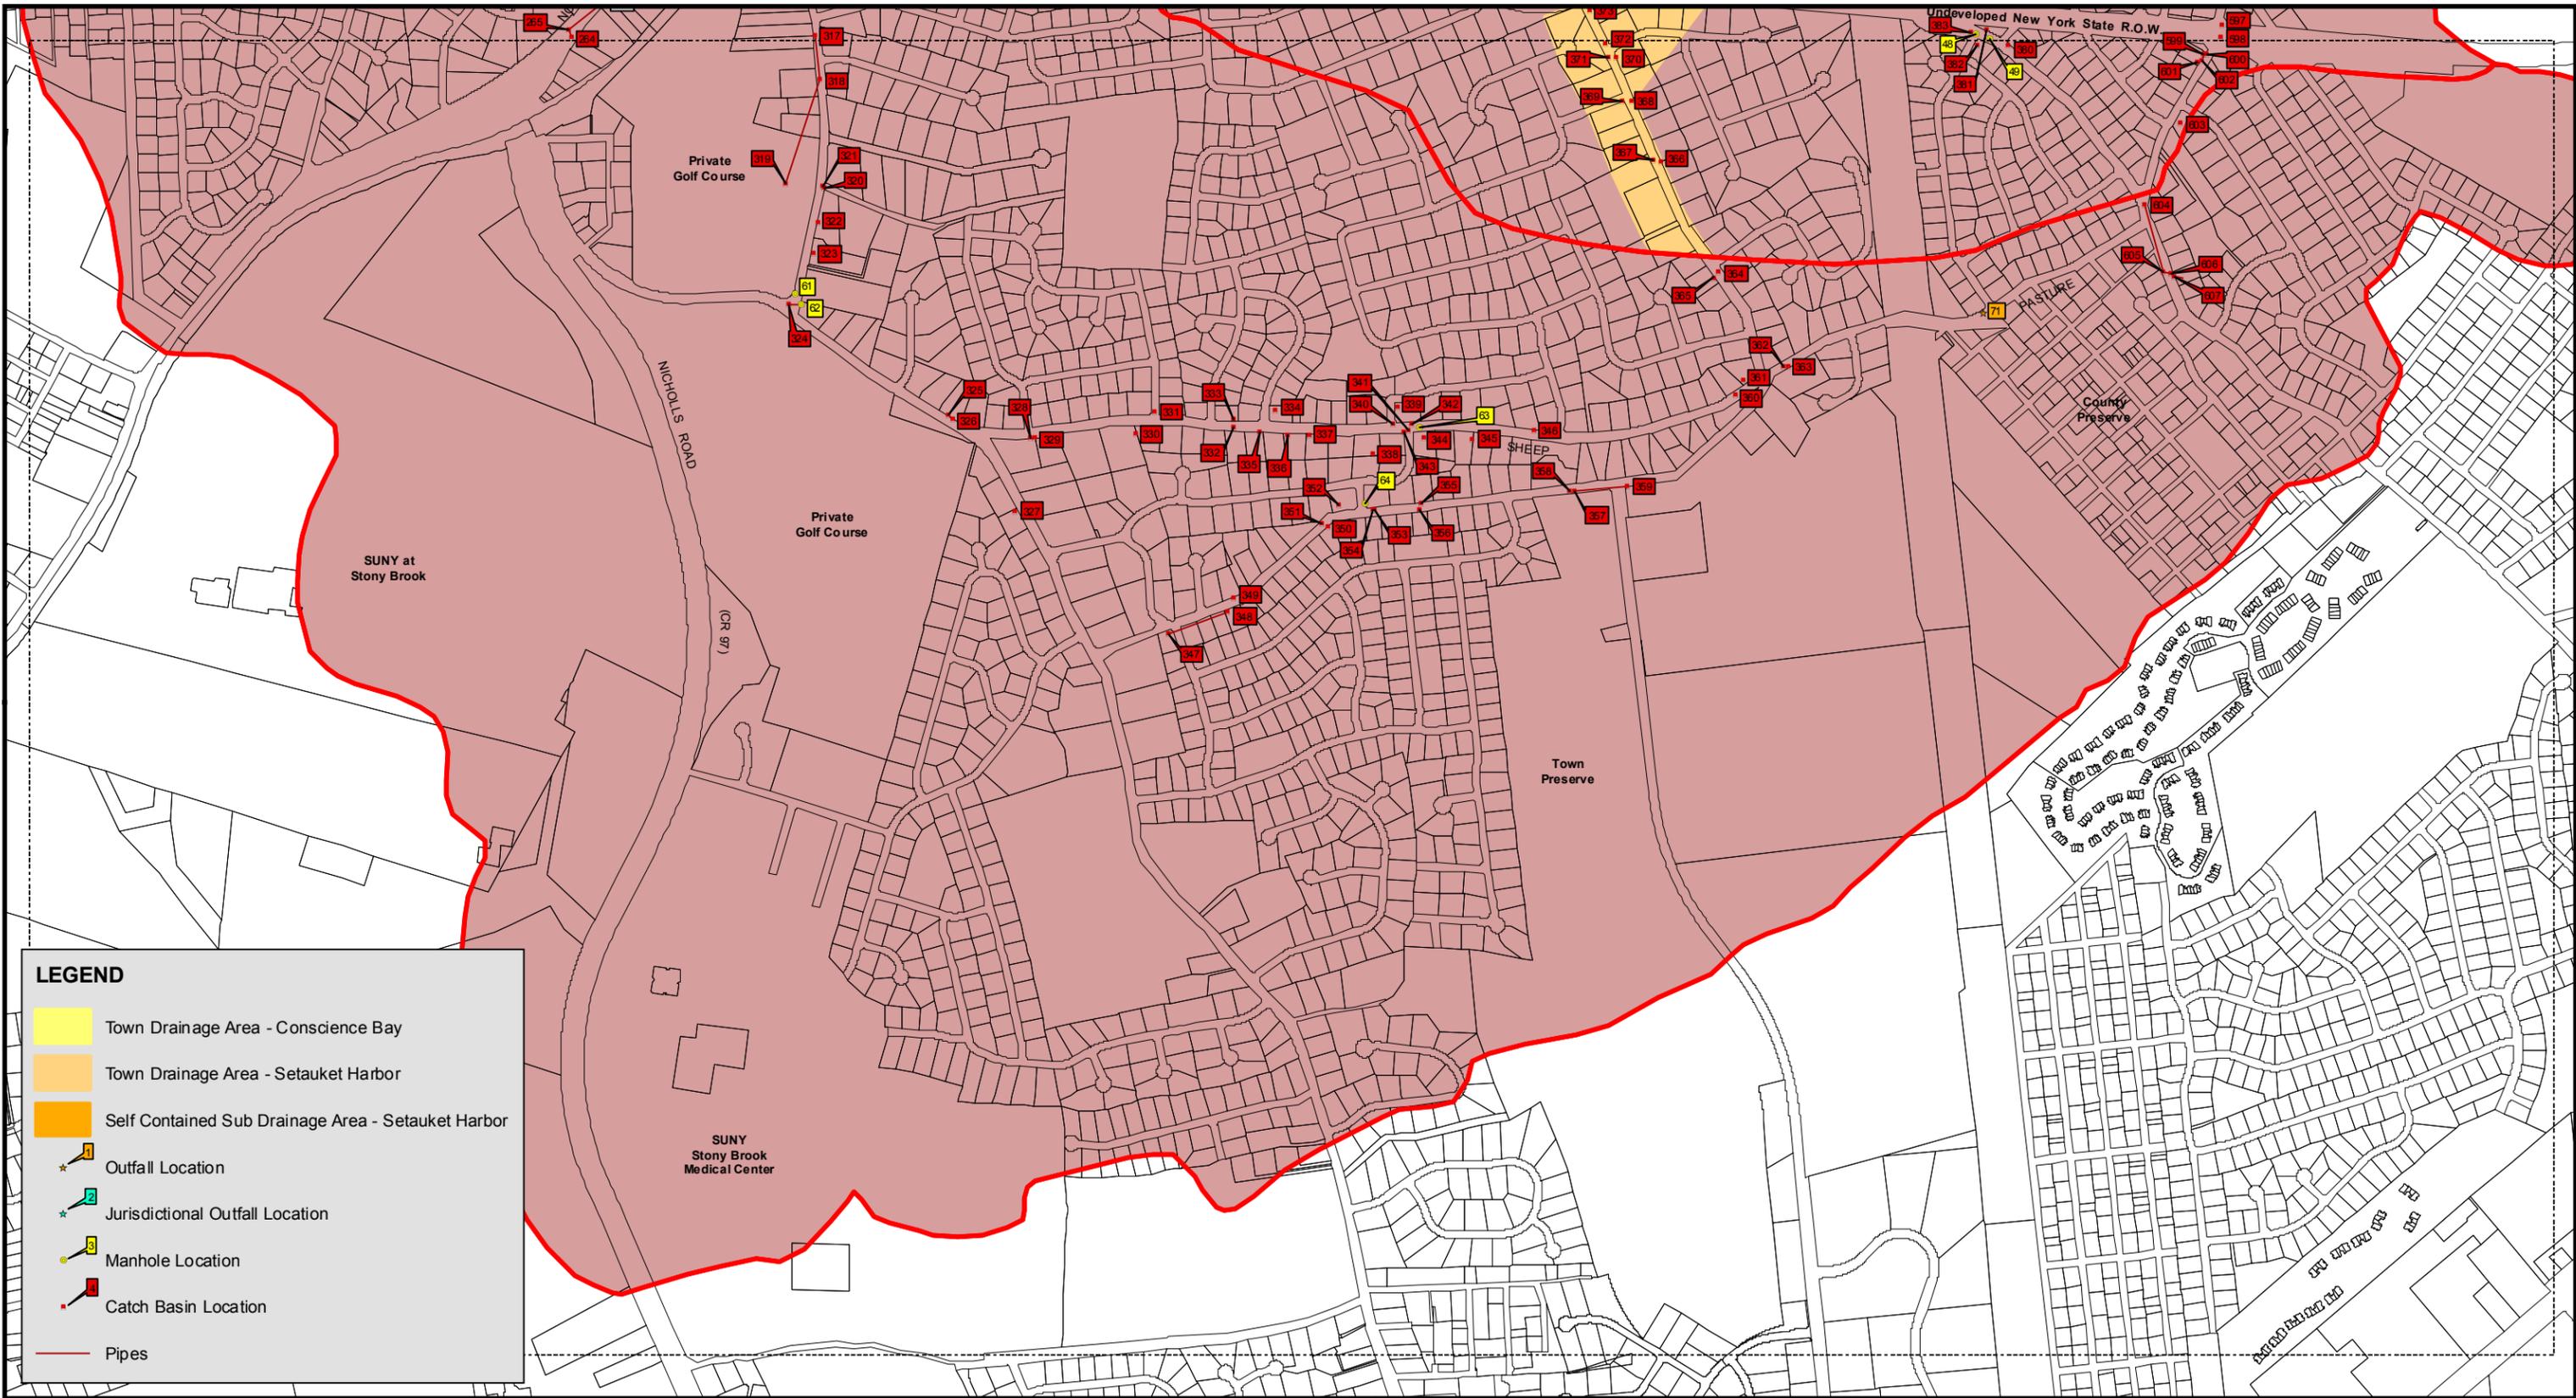
*Conscience Bay and Setauket Harbor
Watershed Plan
Drainage Structures 3
Map 5-3*

- Town Drainage Area - Conscience Bay
- Town Drainage Area - Setauket Harbor
- Self Contained Sub Drainage Area - Setauket Harbor
- Outfall Location
- Jurisdictional Outfall Location
- Manhole Location
- Catch Basin Location
- Pipes
